Champlain Bridge repairs demand inventive solutions

The art and craft of keeping the decrepit span in one piece.

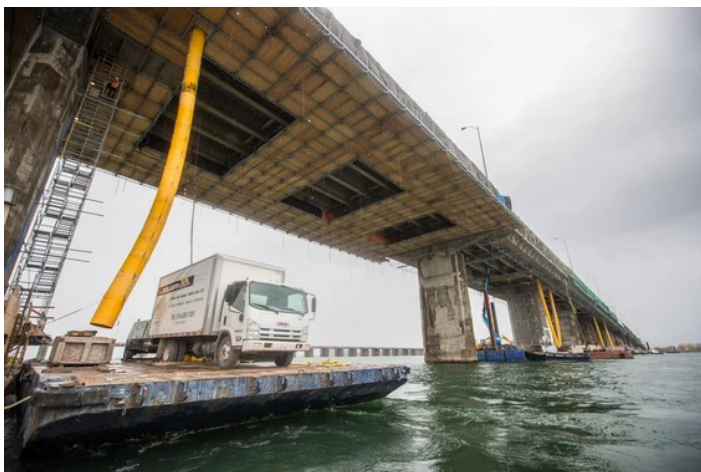
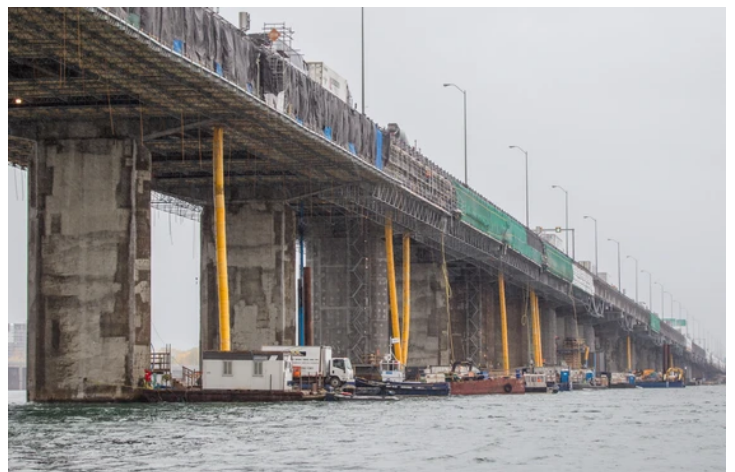
Each beam is made up of 24 steel cables that give the beams their rigidity, but the salt and water infiltration has corroded many of those original cables. Engineers evaluate the strength of each span by taking out a small section of the concrete. They then figure out how many of the cables they believe have corroded, and add capacity, in some cases the equivalent of double the number of cables that have failed. That involves plugging numbers into a formula that has already been determined by a team of engineers.

Because they can't replace the corroded cables or the problematic beams, engineers have come up with innovative ways of reinforcing the structure from the outside.

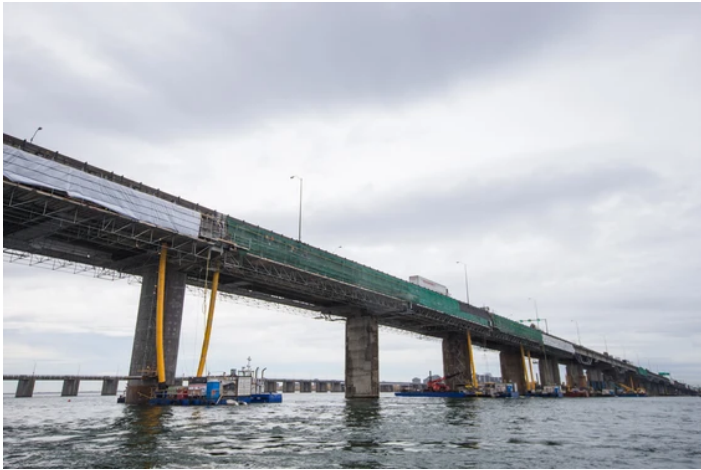
- Concrete anchors are added at the ends of each beam, and are connected by horizontal posts that are tightened, which engineers call external post-tensioning. Those posts stop vertical cracks from forming in the beams.
